## Historic Structure Report for St. Anne's Church

# Historic Structure Report for St. Anne's Church

National Park Service  
Historic Preservation Fund Project  
#23-11-NA-2314  
July 2013

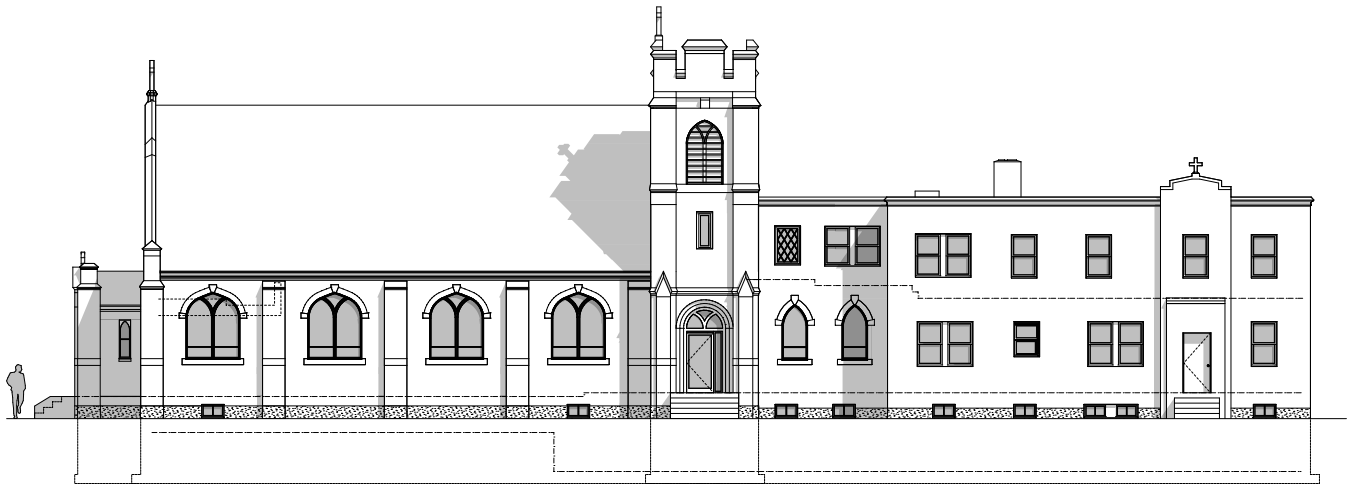
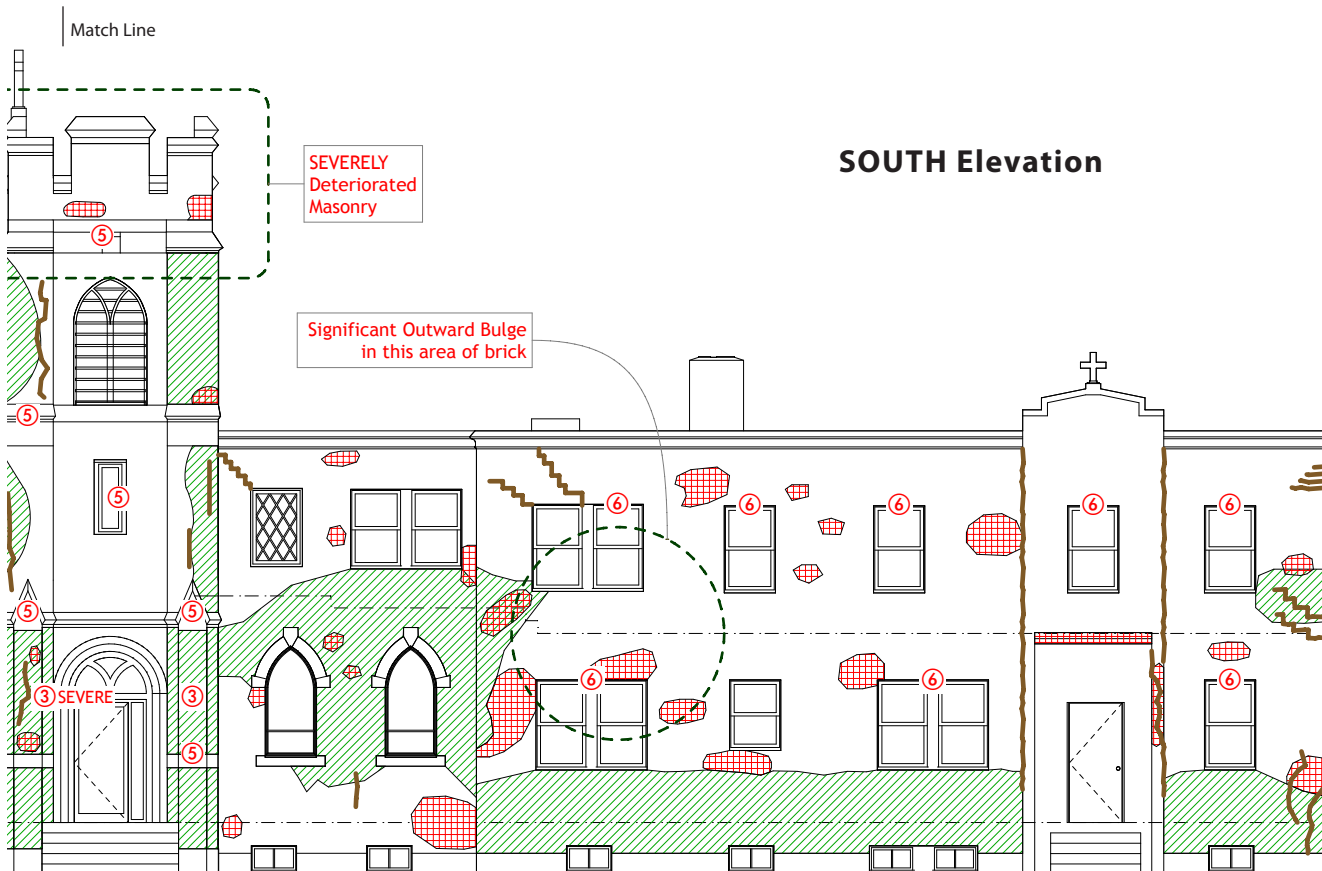
## SOUTH Elevation

- ① Areas of what appear to be non-original brick from previous repairs indicated by color difference, size difference, and lack of header courses.
- ② Areas of extensive brick face spalling due to incorrect re-pointing with high-strength mortar.
- ③ Separation of pilaster/column from building at vertical joint.
- ④ Cracking in brick near granite corner stones.
- ⑤ Deteriorated precast sills and blocks covered in lead-coated copper.
- ⑥ Corroded Steel Lintels.
- ⑦ Major vertical cracks in brick.

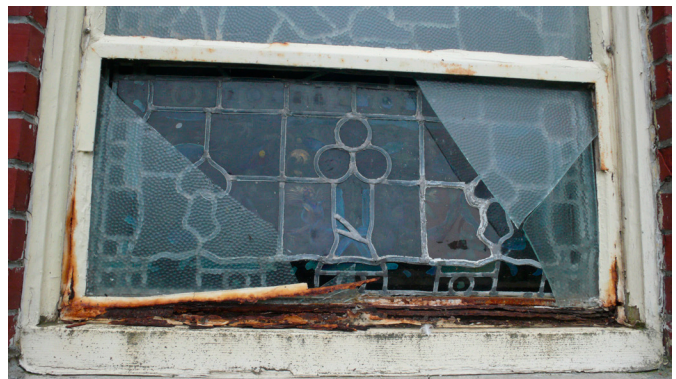
*The metal frame is badly rusted, protective glass is broken and the stained glass is severely bowing. This window is in danger of being lost if the problem is not corrected soon.*

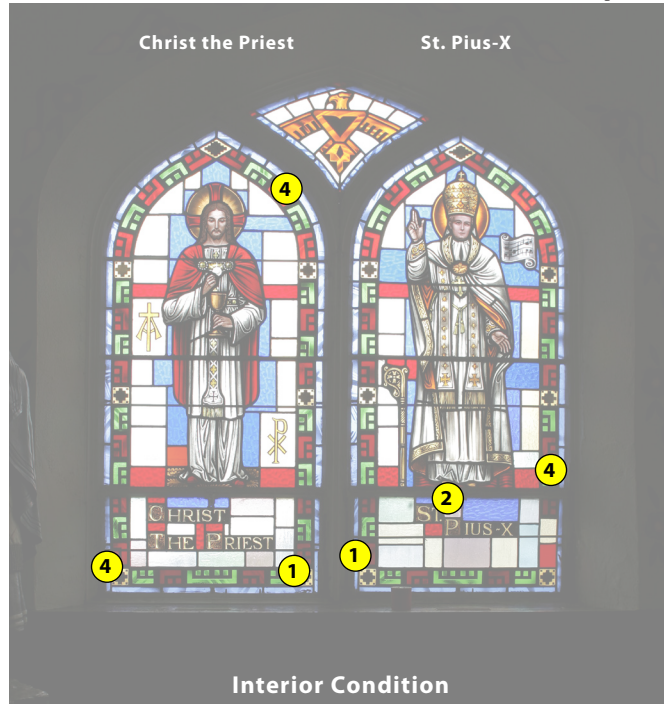
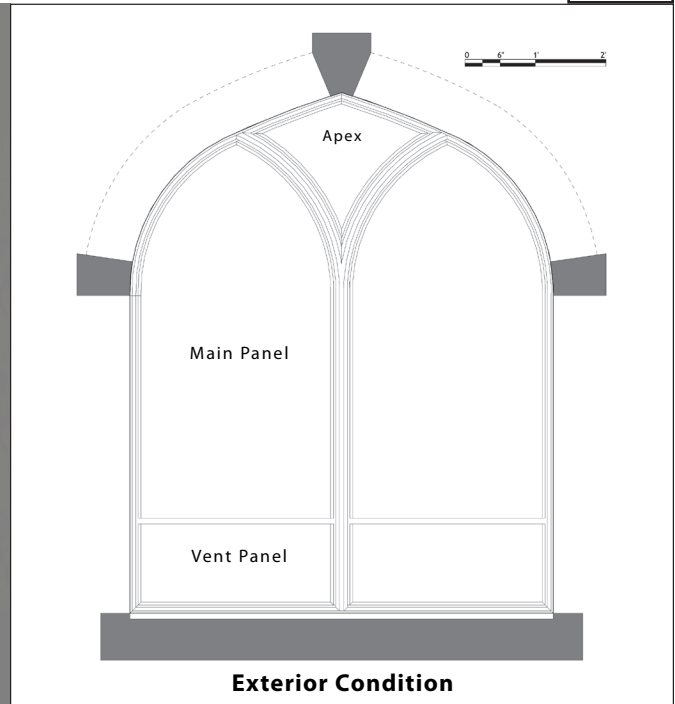
**Window****A**

<i>left panel</i>	<i>right panel</i>
MAIN Panel	no breaks or cracks	one crack
VENT Panel	(1) broken, painted piece	(1) broken, painted piece

All bars and ties are in satisfactory condition. Window supporting bar not well-seated in sash. (Christ the Priest)

Interior and exterior sash generally satisfactory, some minor repair needed, slight water damage interior upper right hand corner.

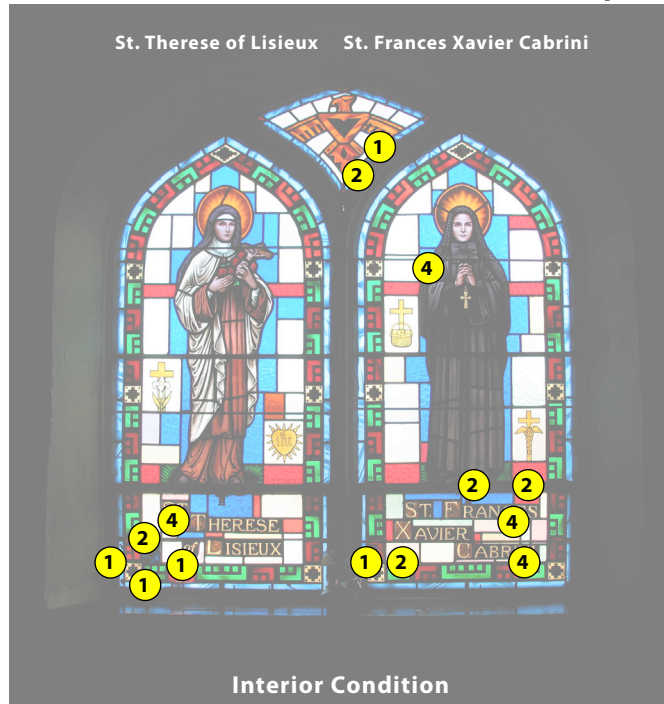
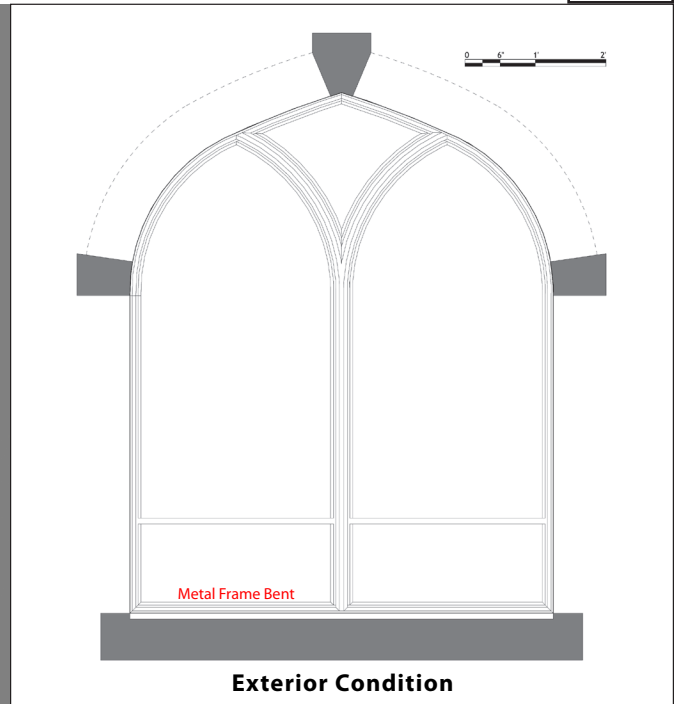
**Window****B**

<i>left panel</i>	<i>right panel</i>
MAIN Panel	one fracture	one fracture
VENT Panel	(3) broken, painted pieces; one broken piece; one fracture	(1) broken, painted piece; (3) broken pieces; (1) fracture

MAIN Panel	none	none
VENT Panel	buckling (repair)	bowed (monitor)

Interior sash generally satisfactory, left ventilator frame (metal) is bent and in need of replacement.

The Thunderbird window at the apex  
has one fracture and one break.  
Part of the grouping of (8) double portrait windows

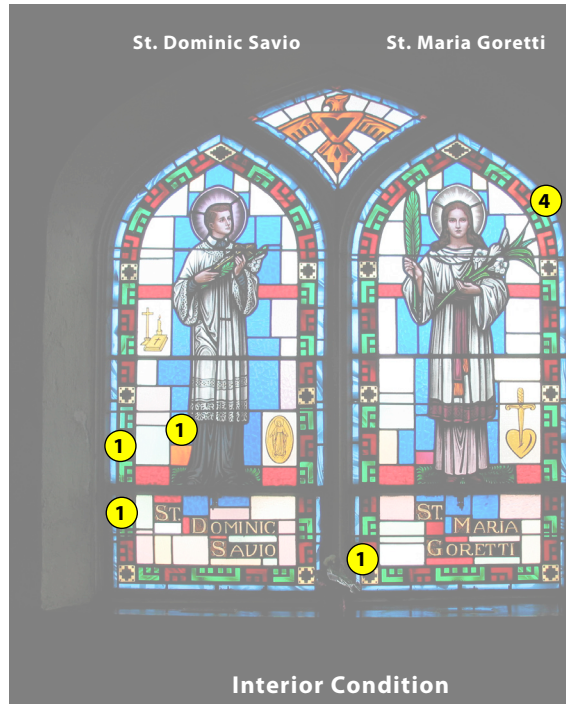
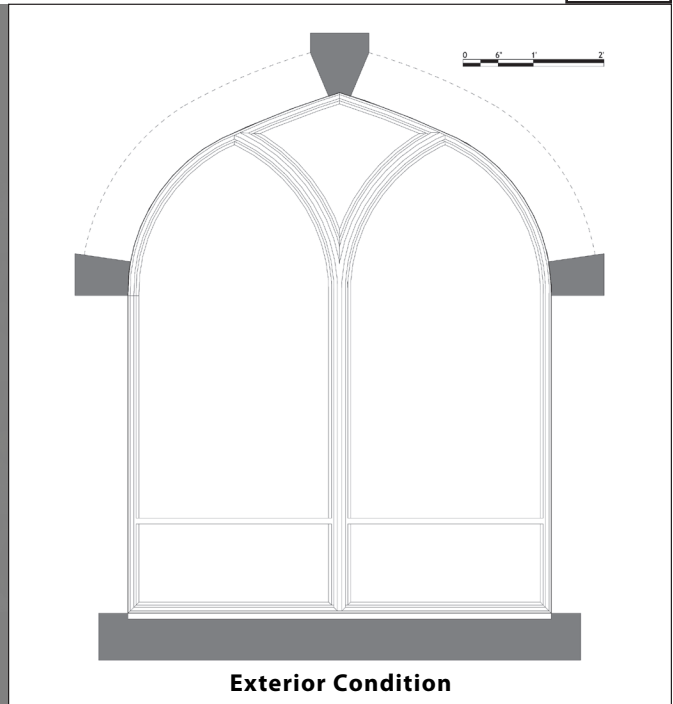
**Window****C**

<b>MAIN Panel</b>	(1) broken, painted piece; one broken piece	one fracture
<b>VENT Panel</b>	one fracture	(1) broken, painted piece

<b>MAIN Panel</b>	Plexiglas	Glass and Plexiglas
<b>VENT Panel</b>	Glass and Plexiglas (ext. cracked)	Glass and Plexiglas (inner cracked)

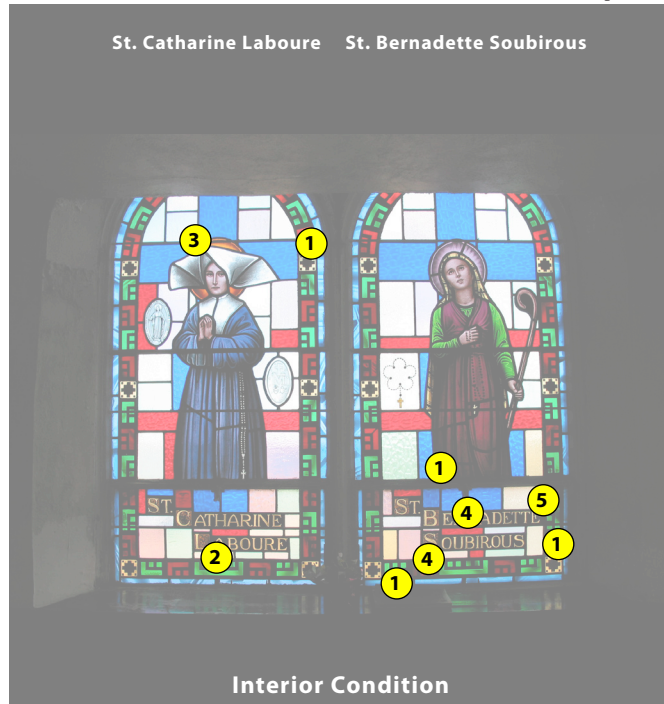
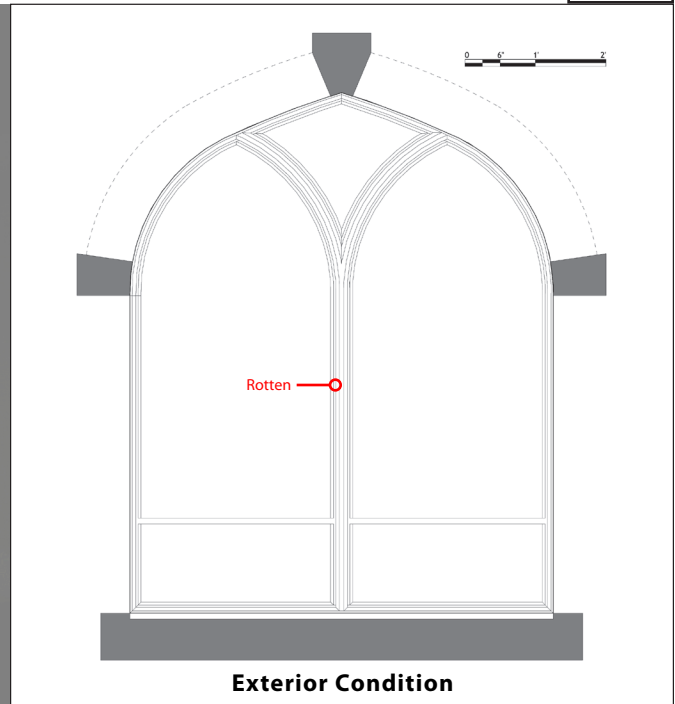
**Window****D**

<i>left panel</i>	<i>right panel</i>
MAIN Panel	(1) broken, painted piece	(1) broken, painted piece
VENT Panel	(1) broken piece	(1) broken, painted piece; (4) fractures

MAIN Panel	satisfactory	satisfactory
VENT Panel	satisfactory	a few breaks, missing piece (repair)

All bars and ties are in satisfactory condition, save for one broken tie in left main panel.

Significant rot in center of exterior sash; both ventilator windows are rotten at the base.

One of two windows in this group in which the figure is cropped at the knees to bring the head under the lowered ceiling. Access to upper portion of main panels and the Thunderbird is impacted by choir loft. As a result, the left main panel is loose and was never puttied into the sash. The Thunderbird was never puttied into the sash. Part of the grouping of (8) double portrait windows.

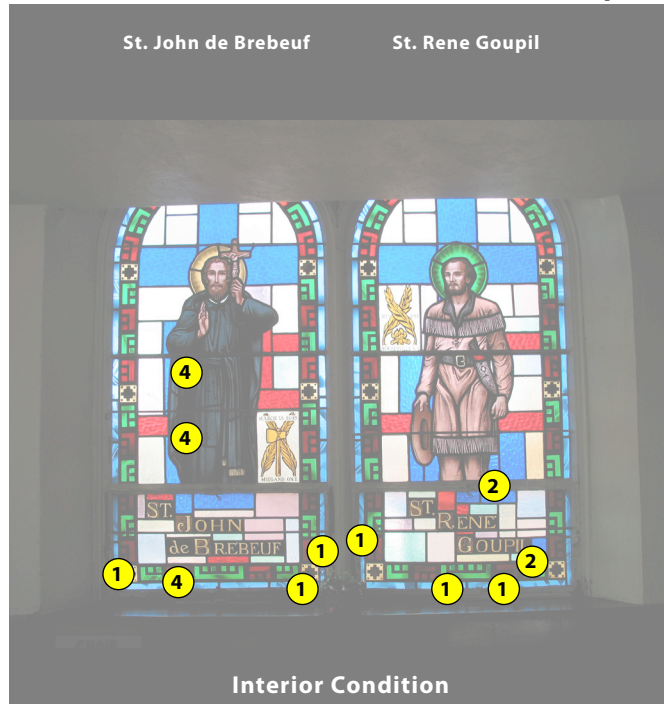
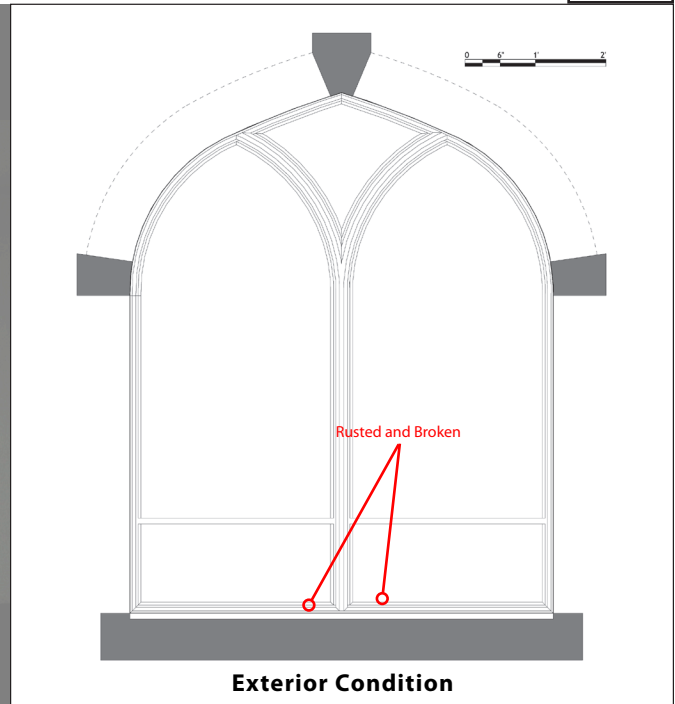
**Window****E**

<i>left panel</i>	<i>right panel</i>
MAIN Panel	(2) fractures	no breaks or fractures
VENT Panel	(3) broken painted pieces; (1) fracture	(3) broken, painted pieces; (2) broken pieces

MAIN Panel	none	none
VENT Panel	bowing (repair)	minor bowing (monitor)

Exterior ventilator rusted and broken.

The other of two windows in this group in which the figure is cropped at the knees to bring the head under the lowered ceiling. Access to upper portion of main panels and the Thunderbird impacted by choir loft. Thunderbird window never puttied into the sash. Part of the grouping of (8) double portrait windows

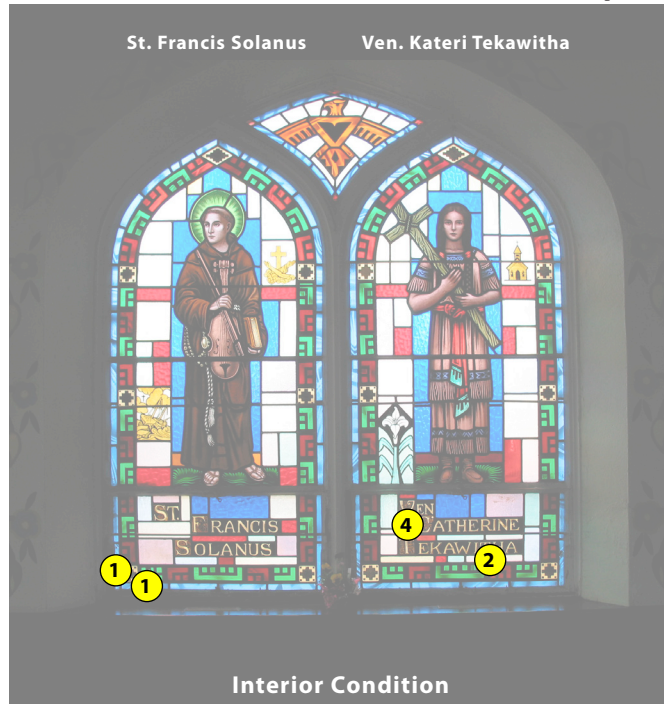
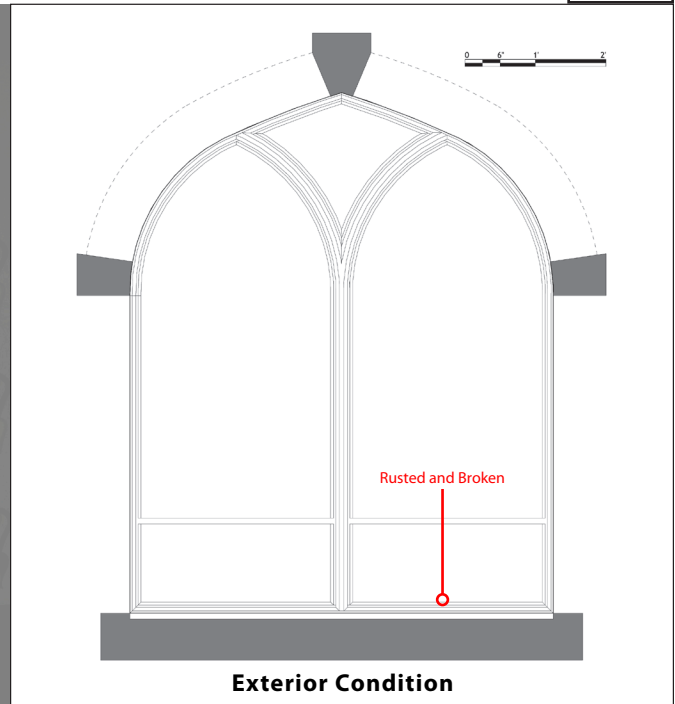
**Window****F**

<b>MAIN Panel</b>	no breaks or fractures	no breaks or fractures
<b>VENT Panel</b>	(2) broken painted pieces	(1) broken piece, (1) fracture

<b>MAIN Panel</b>	satisfactory	satisfactory
<b>VENT Panel</b>	missing on border, left & right	satisfactory

<b>MAIN Panel</b>	none	none
<b>VENT Panel</b>	extreme bowing (repair)	minor bowing (monitor)

All bars and ties are in satisfactory condition.

Exterior ventilator rusted and broken on  
right side (ext. perspective).

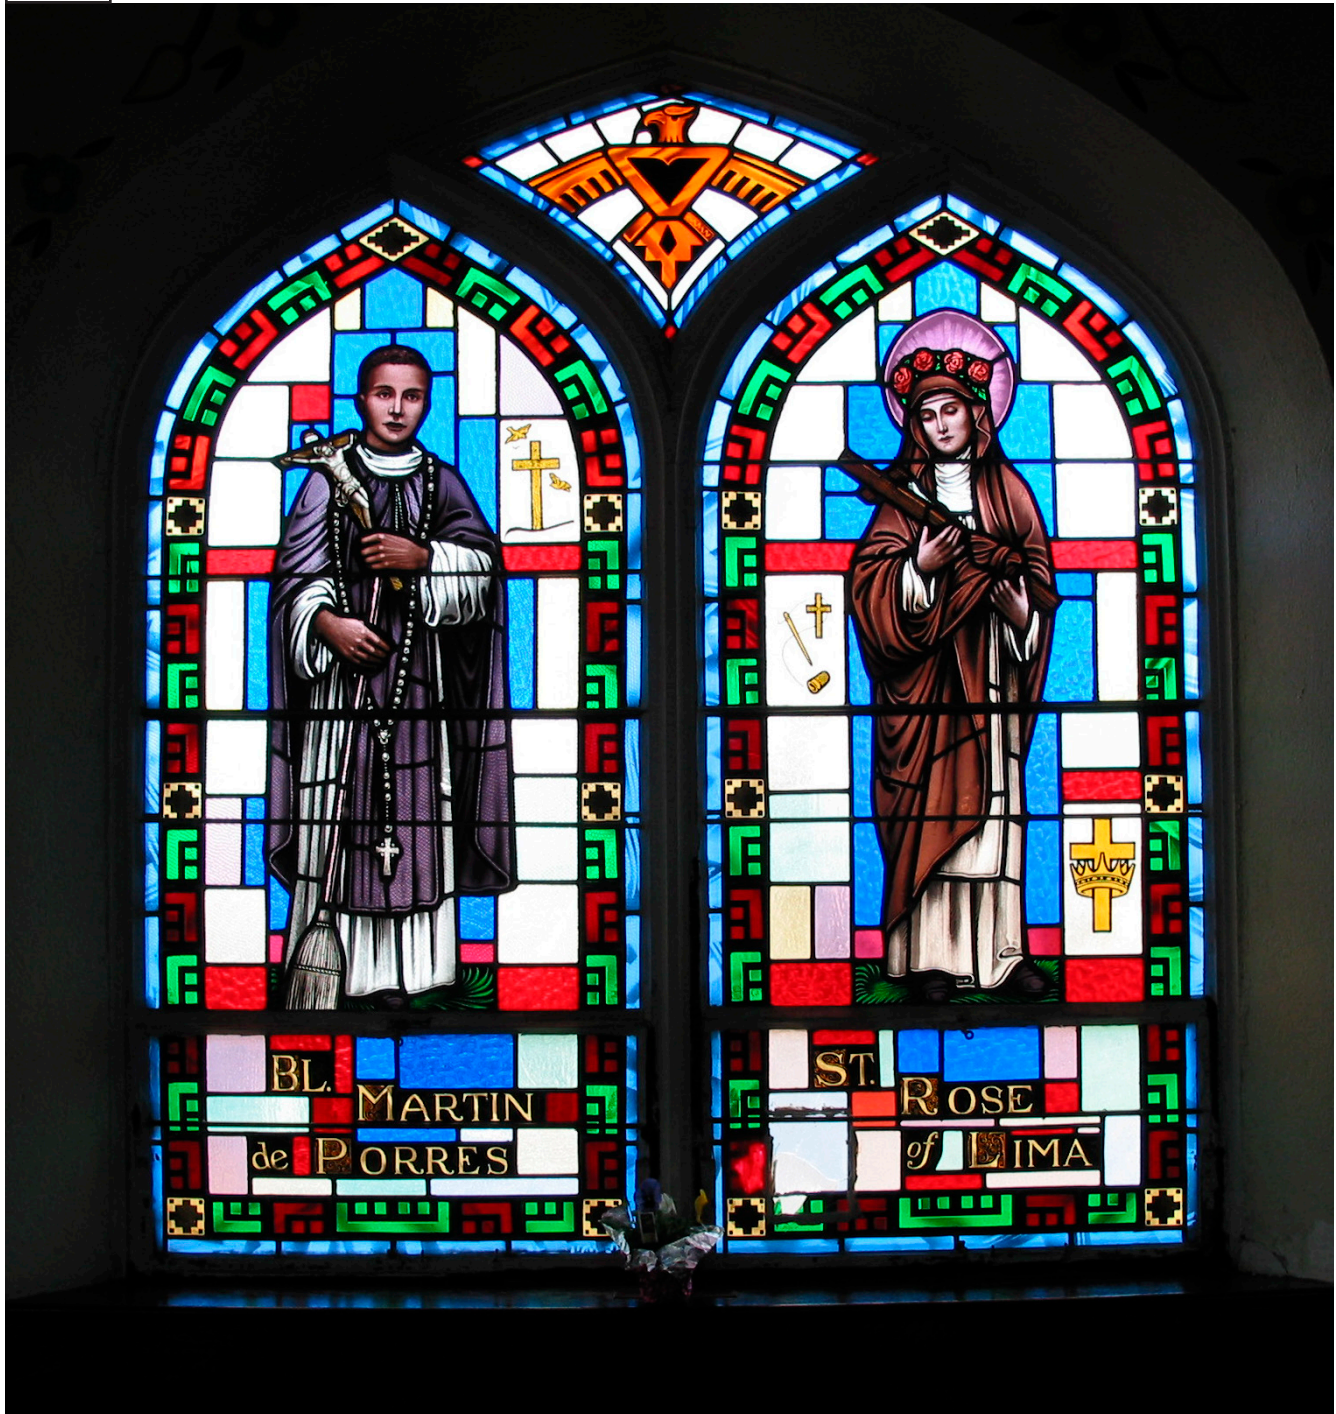
## G

GLASS	left panel	right panel
MAIN Panel	no breaks or fractures	no breaks or fractures
VENT Panel	no breaks or fractures	(2) broken painted pieces; (1) broken piece

LEAD	left panel	right panel
MAIN Panel	satisfactory	satisfactory
VENT Panel	satisfactory	damage where glass broken

BOWING	left panel	right panel
MAIN Panel	none	none
VENT Panel	extreme bowing(repair)	minor bowing (monitor)

PROTECTIVE COVERINGS	left panel	right panel
MAIN Panel	Plexiglas	Glass (cracked) and Plexiglas
VENT Panel	Plexiglas	Plexiglas

**SUPPORTING BARS & TIES**  
Bars and ties are in satisfactory condition;  
one broken tie in left ventilator.

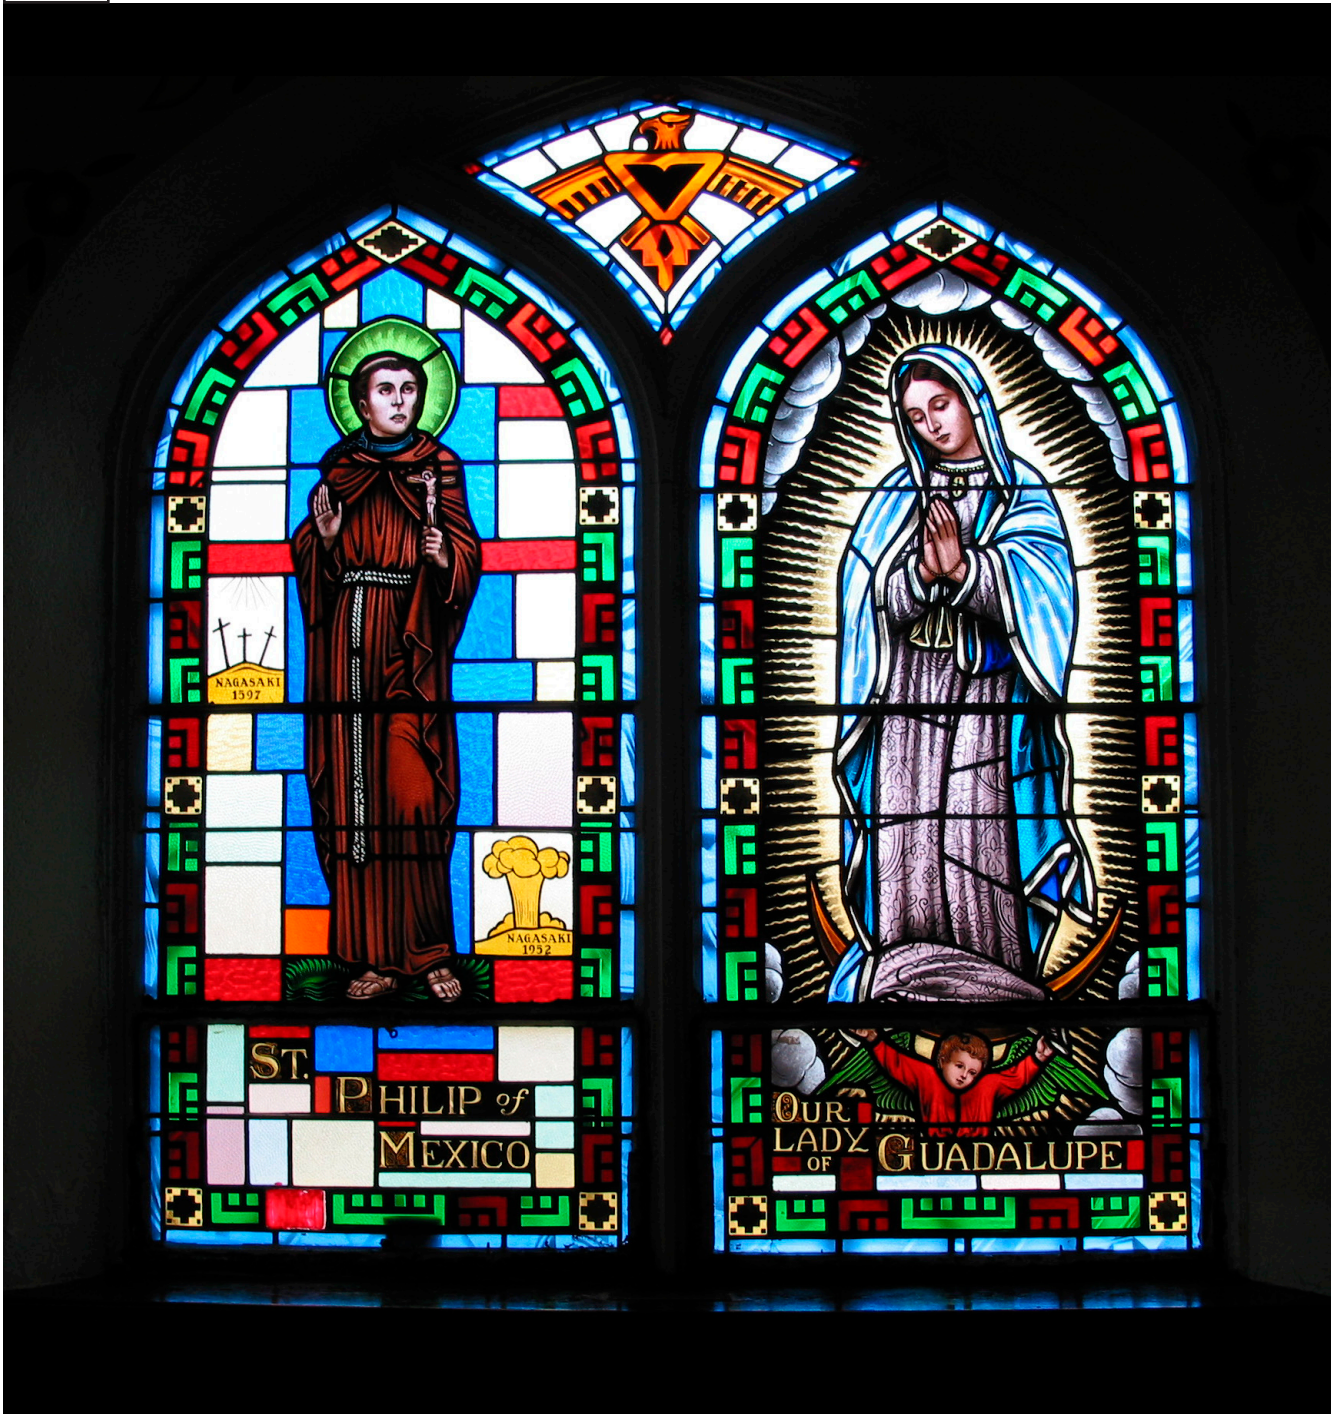
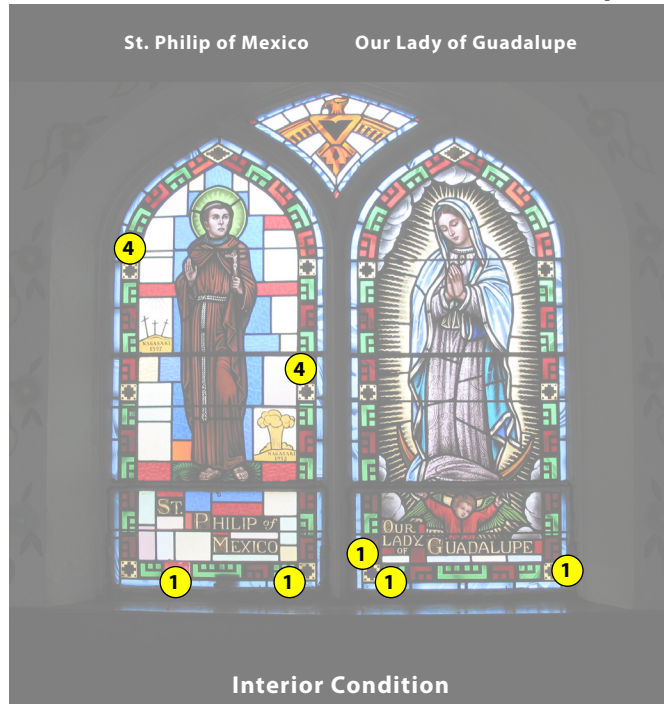
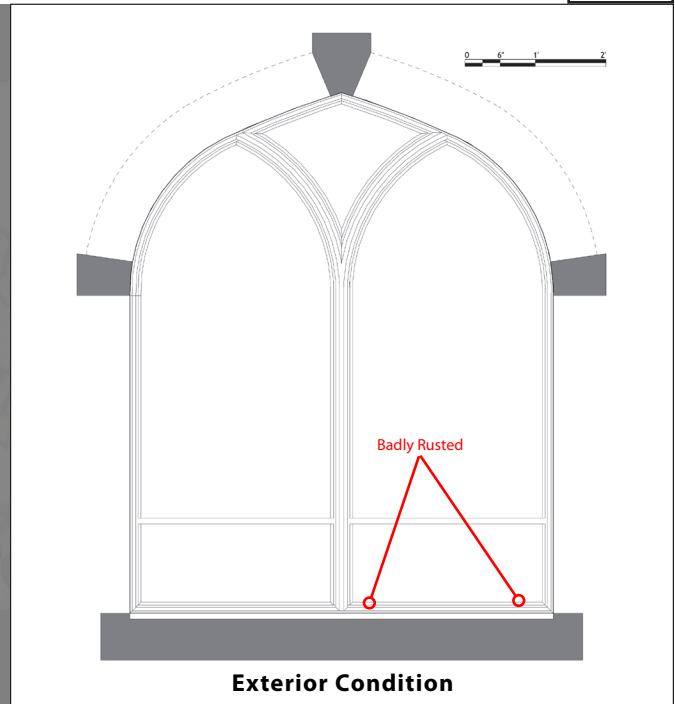
**Window****H**

MAIN Panel	(2) repaired fractures	no breaks or fractures
VENT Panel	(2) broken painted pieces	(3) broken painted pieces

MAIN Panel	Glass and Plexiglas	Glass (cracked) and Plexiglas
VENT Panel	Plexiglas	Glass (broken) and Plexiglas

All bars and ties are in satisfactory condition.

Exterior ventilator rusted and broken on right side (ext. perspective).

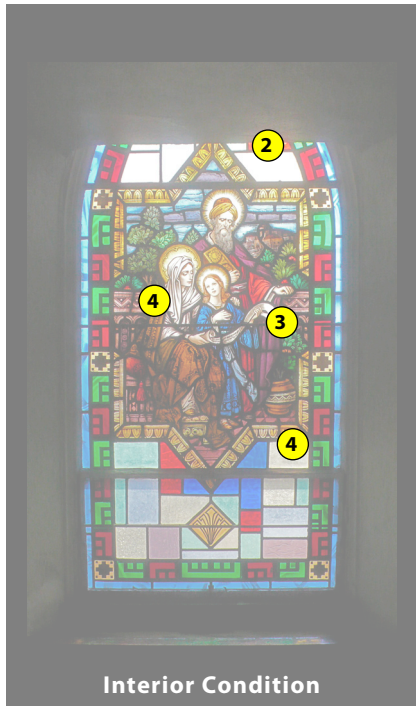
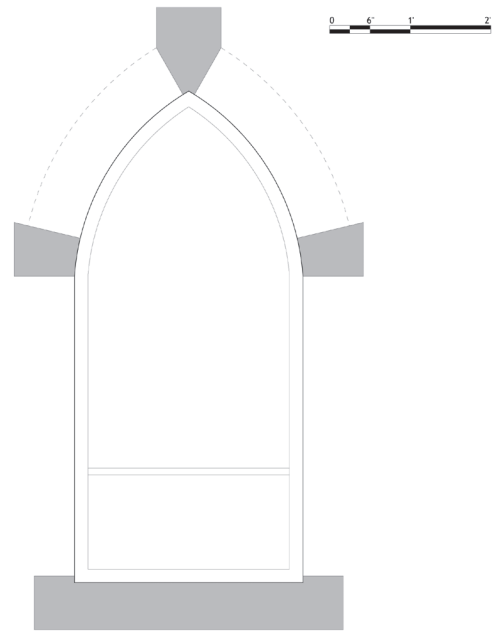
Chapel, 1st Flr, West Side, 1 of 2  
 w33" x 72"h (0.83 x 1.82m)

MAIN Panel (1) break (2) fractures  
 VENT Panel no breaks or fractures

MAIN Panel satisfactory; one piece missing  
 VENT Panel satisfactory

Ties in upper window are loose (repair); vent satisfactory

This window is partially obstructed by the choir loft; upper portion of the main panel is loose and was never puttied into the sash. This window is unique in that it seems to have an inset panel that matches the style of the "English" windows while having a border that matches the double portrait windows.

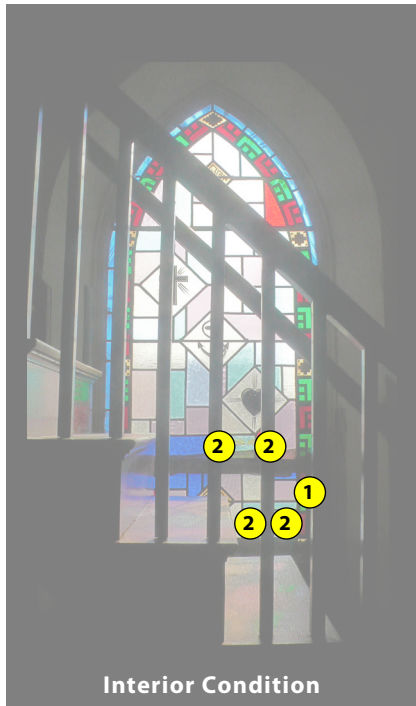
Chapel, 1st Flr, West Side, 2 of 2  
 w33" x 72"h (0.83 x 1.82m)

MAIN Panel satisfactory  
 VENT Panel broken where glass is bowed

All bars and ties are in satisfactory condition.

This window is partially obstructed by the choir loft stairs. Proximity to stairs leaves it vulnerable to damage. It appears to be by the same artist/studio as the portrait windows but is unique as an abstract design

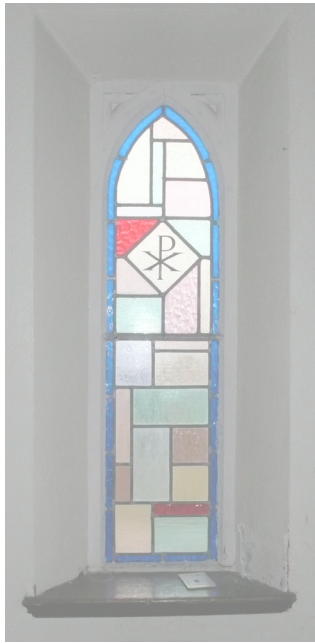
**K**

MAIN Panel no breaks or fractures

All bars and ties are in satisfactory condition.

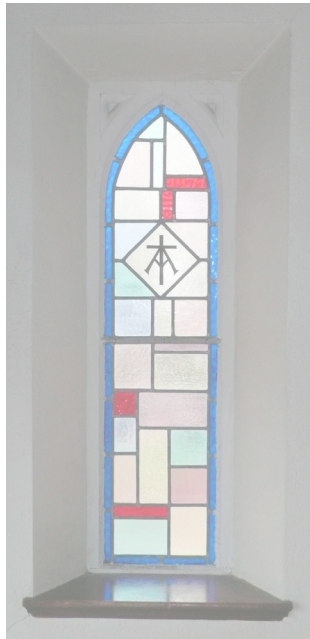
Location : **Chapel Entry, 1st Flr, North Side**  
 Approximate Dimensions : **w15" x 51"h (0.38 x 1.29m)**  
*Consisting of a single panel*

MAIN Panel no breaks or fractures

All bars and ties are in satisfactory condition.

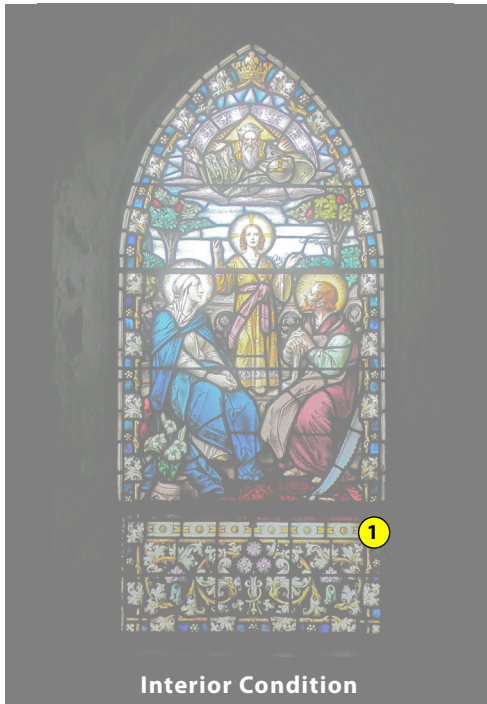
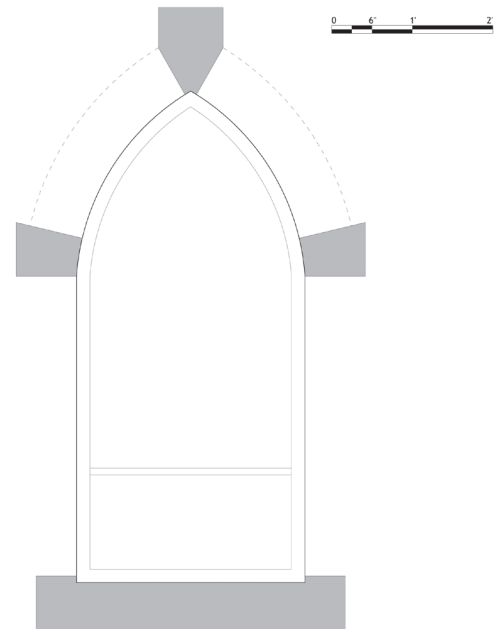
**Vestibule, 1st Flr, North Side, 1 of 2**  
**w33" x 72"h (0.83 x 1.82m)**

**MAIN Panel** no breaks or fractures  
**VENT Panel** (1) broken painted piece

**MAIN Panel** Glass and Plexiglas  
**VENT Panel** Glass (cracked) and Plexiglas

All bars and ties are in satisfactory condition

Exterior ventilator- minor rust

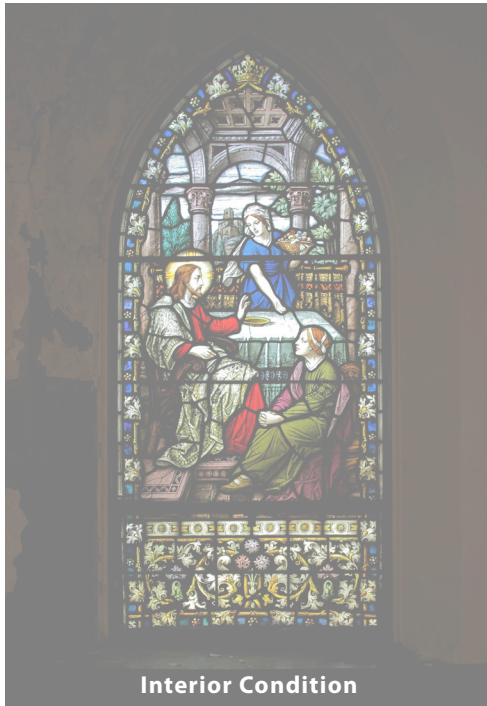
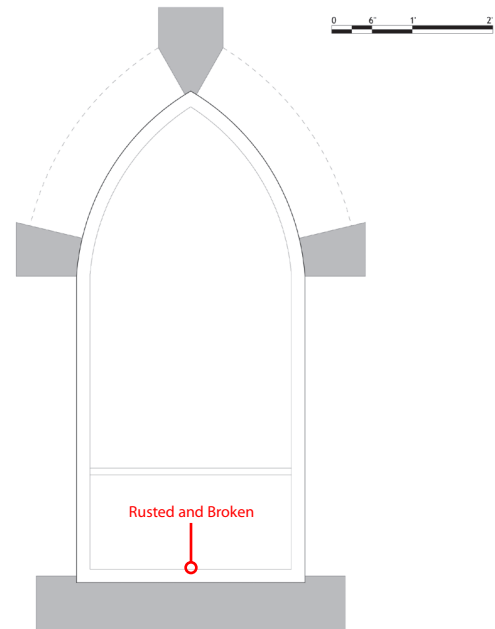
**Vestibule, 1st Flr, North Side, 2 of 2**  
**w33" x 72"h (0.83 x 1.82m)**

**MAIN Panel** no breaks or fractures  
**VENT Panel** no breaks or fractures

**MAIN Panel** Glass  
**VENT Panel** Glass (broken)

All bars and ties are in satisfactory condition

Exterior ventilator rusted and broken at bottom.

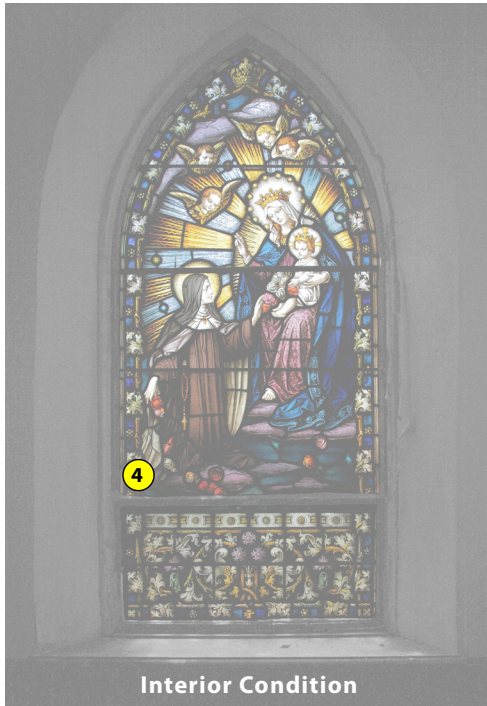
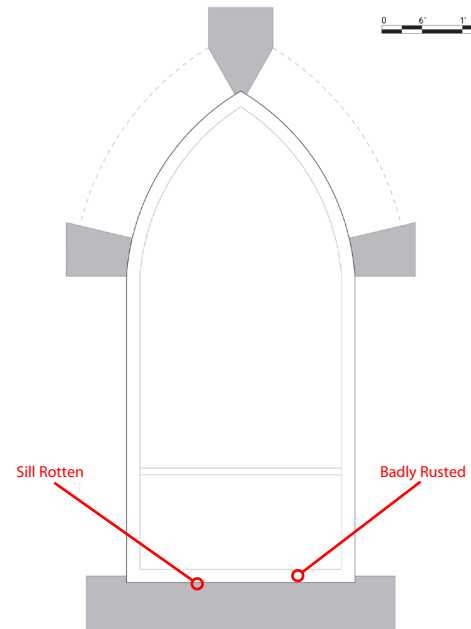
**Vestibule, 1st Flr, South Side, 1 of 2**  
**w33" x 72"h (0.83 x 1.82m)**

**MAIN Panel** no breaks, (1) fracture  
**VENT Panel** no breaks or fractures

**MAIN Panel** Plexiglas  
**VENT Panel** Glass (broken) and Plexiglas

Top bar main panel has broken ties; window loose.

Exterior ventilator badly rusted at bottom.

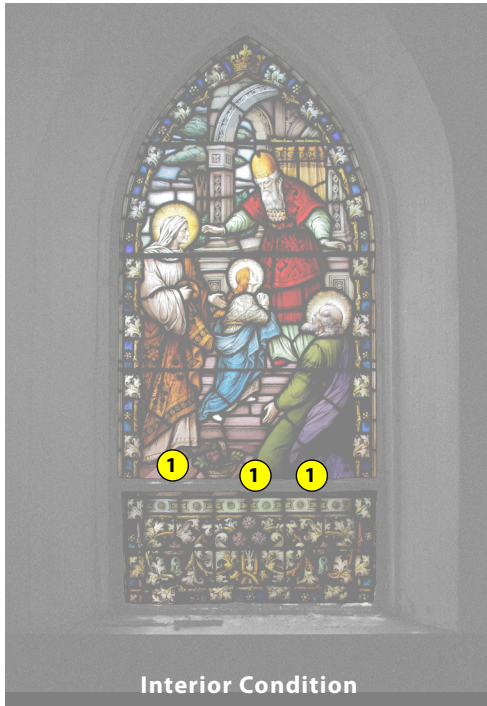
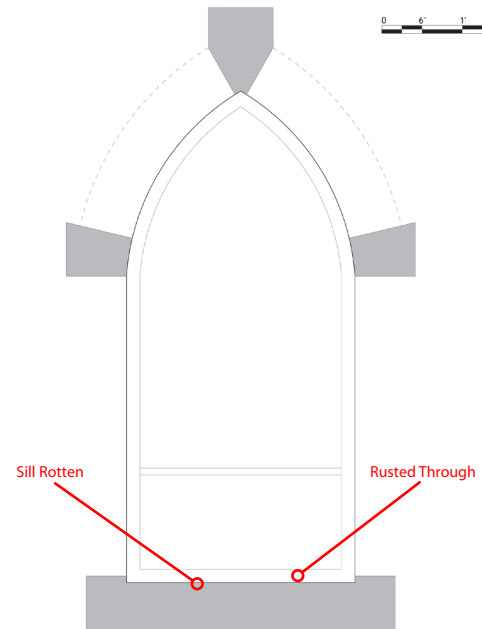
**Vestibule, 1st Flr, South Side, 2 of 2**  
**w33" x 72"h (0.83 x 1.82m)**

**MAIN Panel** (3) breaks in painted glass  
**VENT Panel** no breaks or fractures

**MAIN Panel** satisfactory  
**VENT Panel** poor condition overall (relead)

**MAIN Panel** severe bowing upper section (monitor/repair)  
**VENT Panel** Severely bowed (monitor/repair)

**MAIN Panel** Plexiglas  
**VENT Panel** Glass (broken) and Plexiglas

All bars and ties are in satisfactory condition.

Ventilator rusted through at bottom (replace); exterior sash damp and rotting, upper right corner.

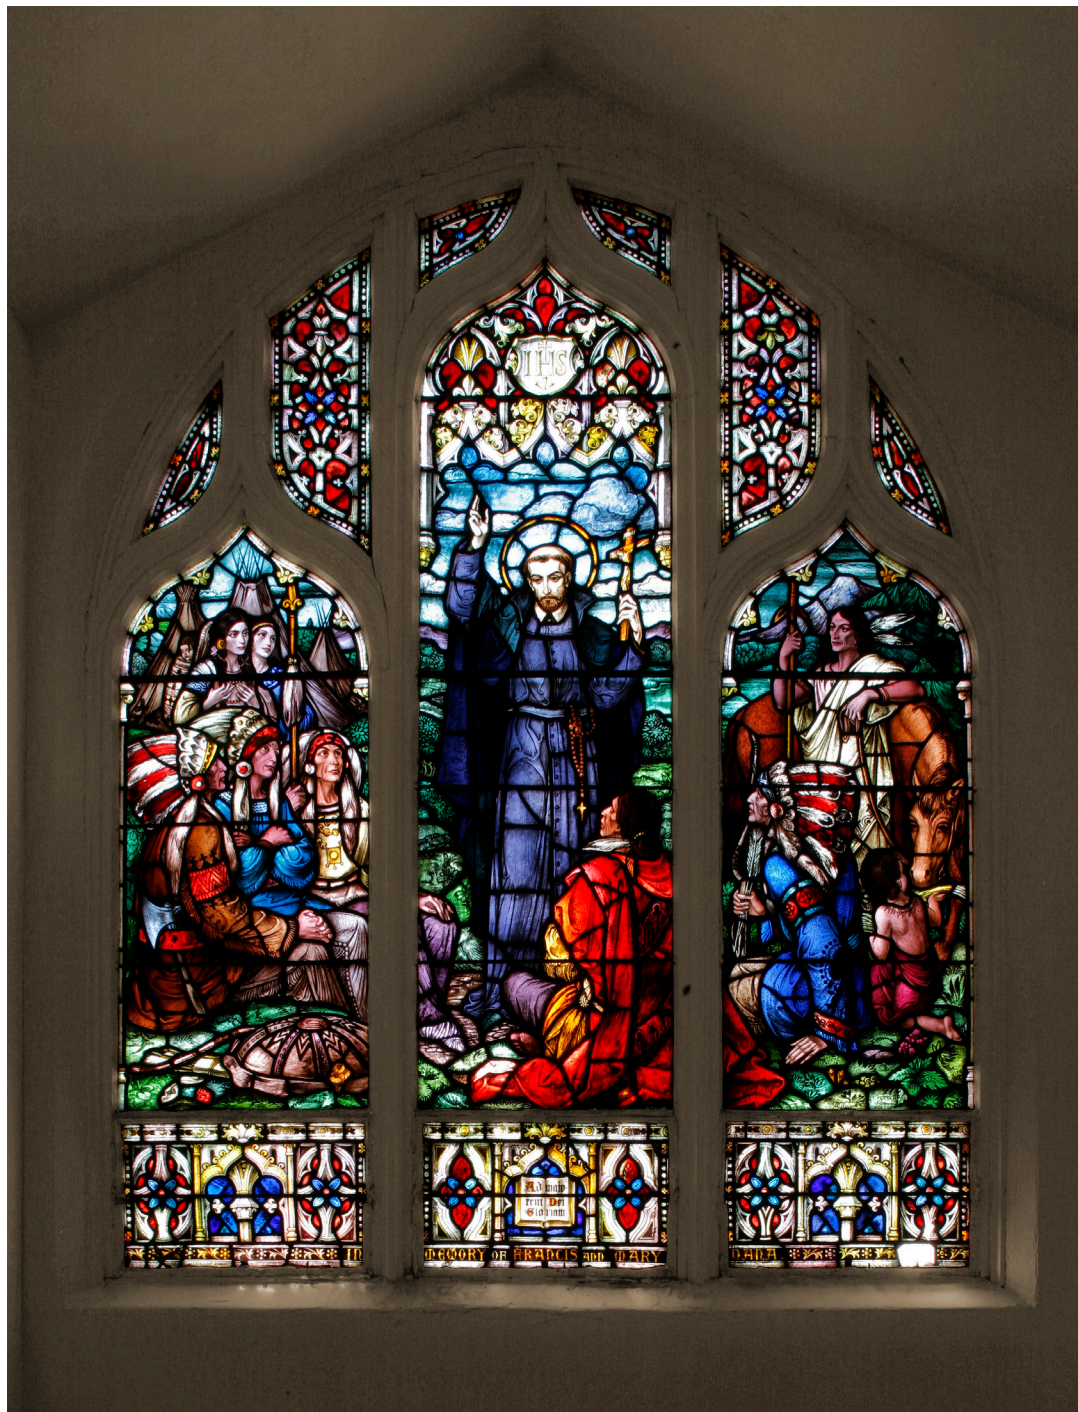
Choir Loft, 2nd Flr, West Side  
w89" x 111"h (2.26 x 2.81m)

GLASS	CENTER panel	LEFT panel	RIGHT panel
MAIN Panel	no breaks or fractures	(3) broken painted pieces; (1) fracture	(1) fracture
VENT Panel	(2) breaks in painted glass	(2) broken painted pieces	(4) broken painted pieces; (1) fracture

BOWING	CENTER panel	LEFT panel	RIGHT panel
MAIN Panel	significant bowing in "halo" area (monitor/repair)	minor bowing in lower section	none
VENT Panel	minor bowing (monitor)	bowing (repair)	none

PROTECTIVE COVERINGS	CENTER panel	LEFT panel	RIGHT panel
MAIN Panel	Plexiglas (broken)	Glass and Plexiglas (cracked)	Plexiglas
VENT Panel	Glass and Plexiglas (cracked)	Glass (cracked)	Plexiglas

SUPPORTING BARS & TIES	All bars and ties are in satisfactory condition except for one tie in the center of the ventilator.	satisfactory	satisfactory
------------------------	---	--------------	--------------

SASH	Interior/exterior sash generally satisfactory except for bottom of ventilator which is rusted through (repair).	interior sash generally satisfactory	interior sash generally satisfactory
------	---	--------------------------------------	--------------------------------------

A broken, single sheet of Plexiglas only partially covers the lower part of the main panel and the ventilator. This should be remedied immediately. This is the largest stained glass window. The largest of the small windows above left is missing sash putty on the center side; its opposite companion on the right is slightly bowed and should be monitored. Lead is satisfactory on all of these windows, and they all have glass and Plexiglas protective coverings. The right ventilator window has been repaired badly in the left/center area.

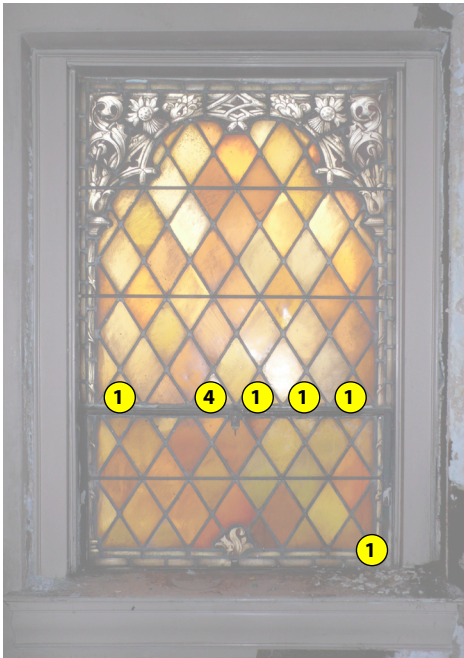
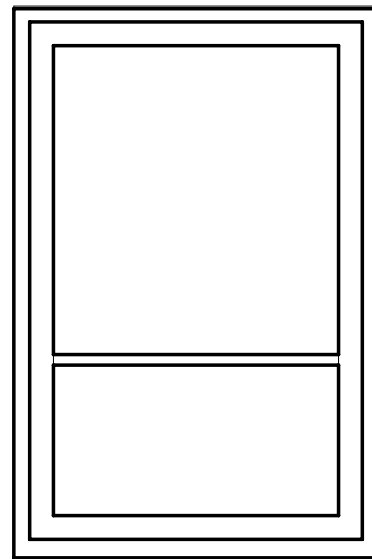
**R**

MAIN Panel (4) breaks in painted glass; (1) fracture

MAIN Panel some damage to lead at bottom

All bars and ties are in satisfactory condition.

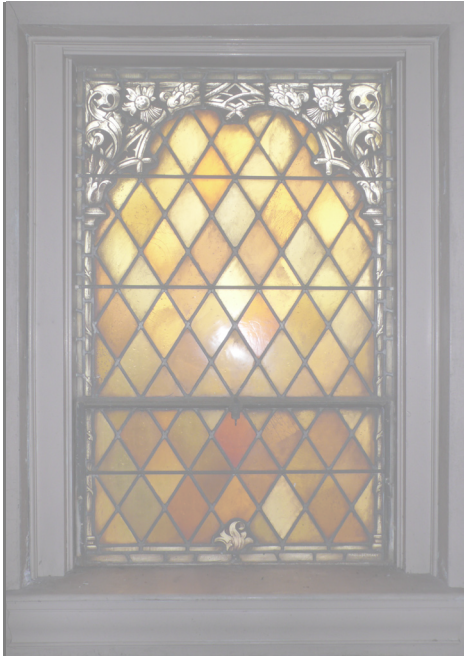
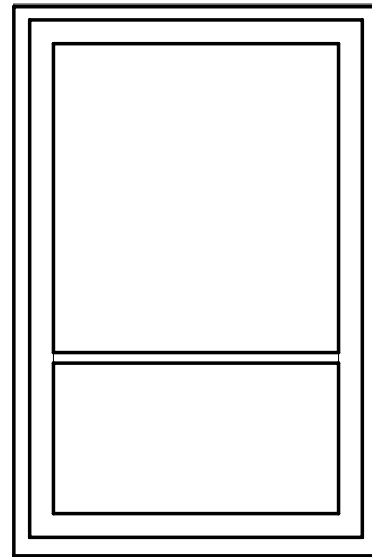
S

MAIN Panel no breaks or fractures  
 VENT Panel no breaks or fractures

All bars and ties are in satisfactory condition.
